Feasibility Study of Retractable Louver System on Museum Tower

November 20, 2012

A Review of our Work on Retractable Louvers as a Potential Solution

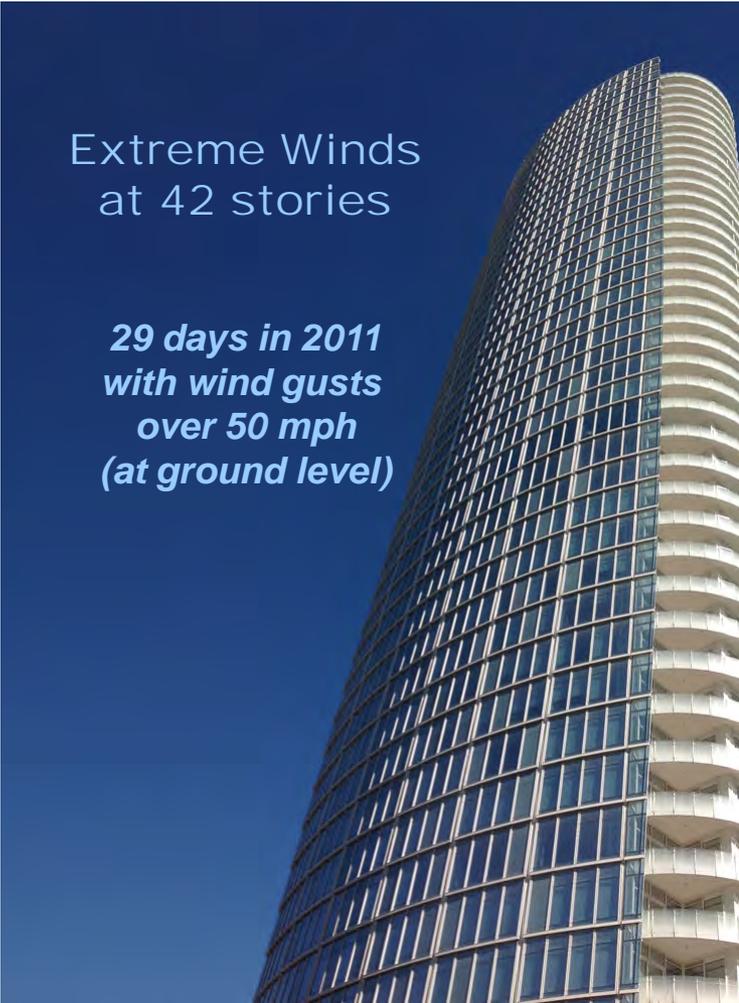
Extreme Winds
at 42 stories

*29 days in 2011
with wind gusts
over 50 mph
(at ground level)*

- Wind Tunnel Test data from the manufacturer indicates that the louver system is approved for applications with a maximum wind speed of **53 mph**.
- In 2011, the National Weather Service recorded **29** days with wind speeds that reached **between 50 and 80 mph**.
- Additionally, wind speeds increase dramatically around high-rise towers.

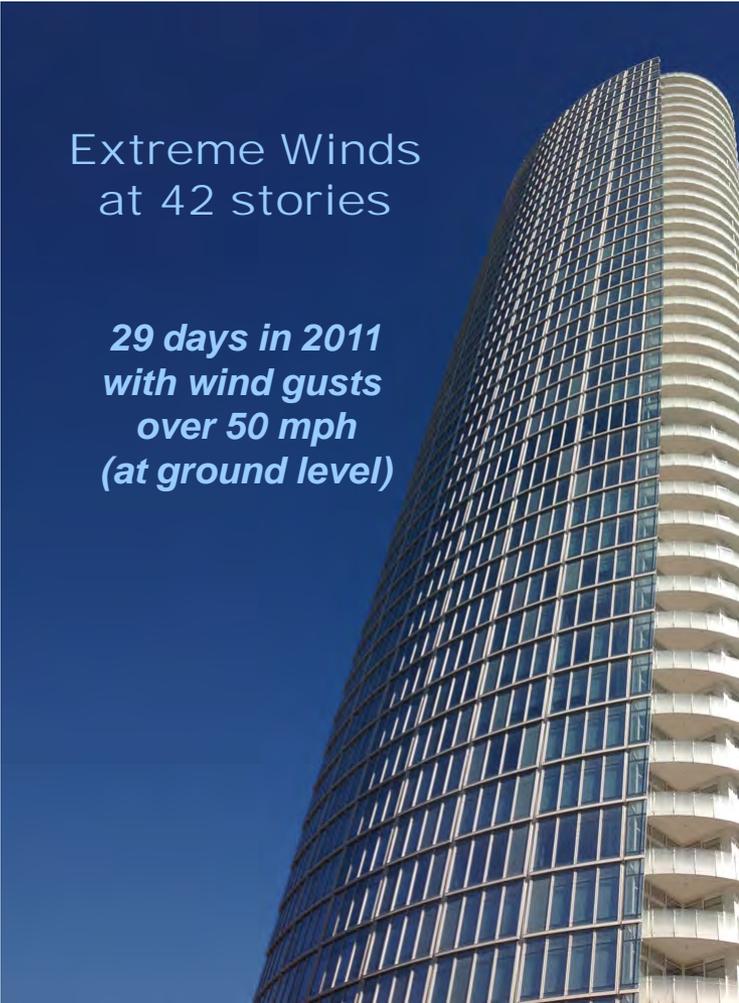
Extreme Winds
at 42 stories

*29 days in 2011
with wind gusts
over 50 mph
(at ground level)*

- Retractable louvers have not been proven reliable for gusty winds in Dallas, TX. The inability to guarantee that the louvers will stay attached to Museum Tower during windy conditions could be potentially hazardous to the public and neighboring buildings.
- Windy conditions can cause the louvers to vibrate, make noise and potentially detach from the building.
- Insurance underwriters have identified wind is a significant risk factor.
- Louvers will not descend in windy conditions, and are therefore, not a 100% solution to reflected light.

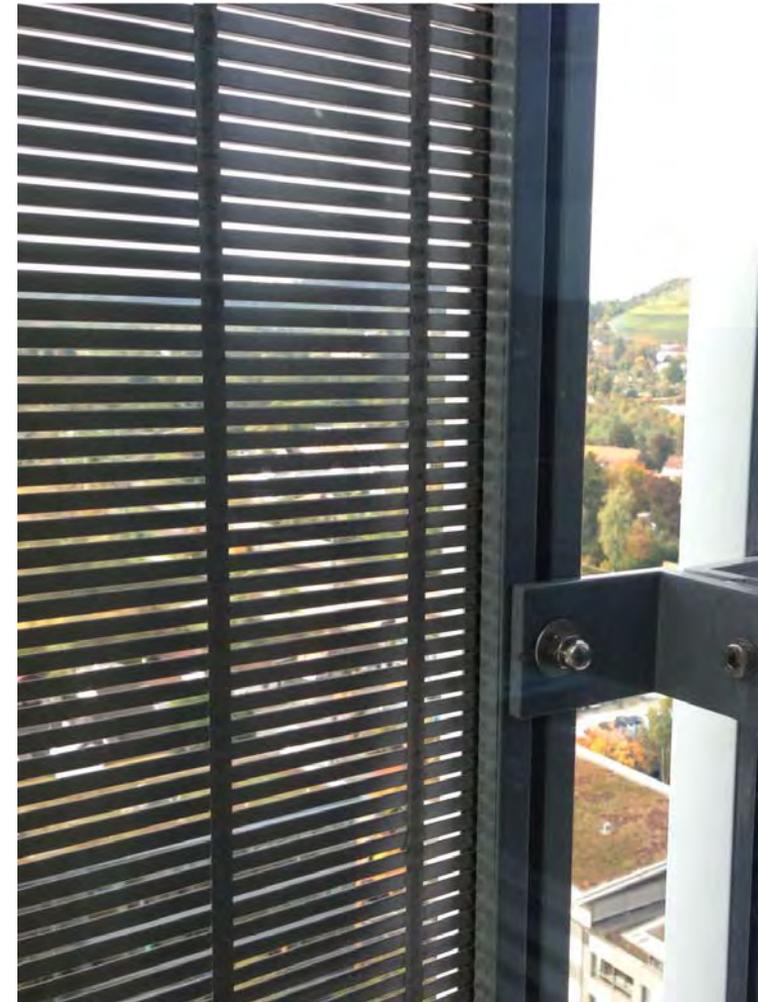
Appearance and Impaired View

- Louver system requires a substantial (9"x12") architectural "head" (rectangular box) that protrudes from the existing curtain wall and obscures the glass shingle system as designed.
- Vertical louver tracks on two sides of each panel will protrude from mullions, modifying the current flat wall design to a deep wall design.
- Louvers alter visibility and lighting levels within residences.
- Louvers minimize interior views down (to the landscape below) and up (to the sky).

The unattractive appearance of the louvers on the building, the impaired views for homeowners make the louver system an aesthetically unpleasant treatment for both the Arts District and the owners of Museum Tower.

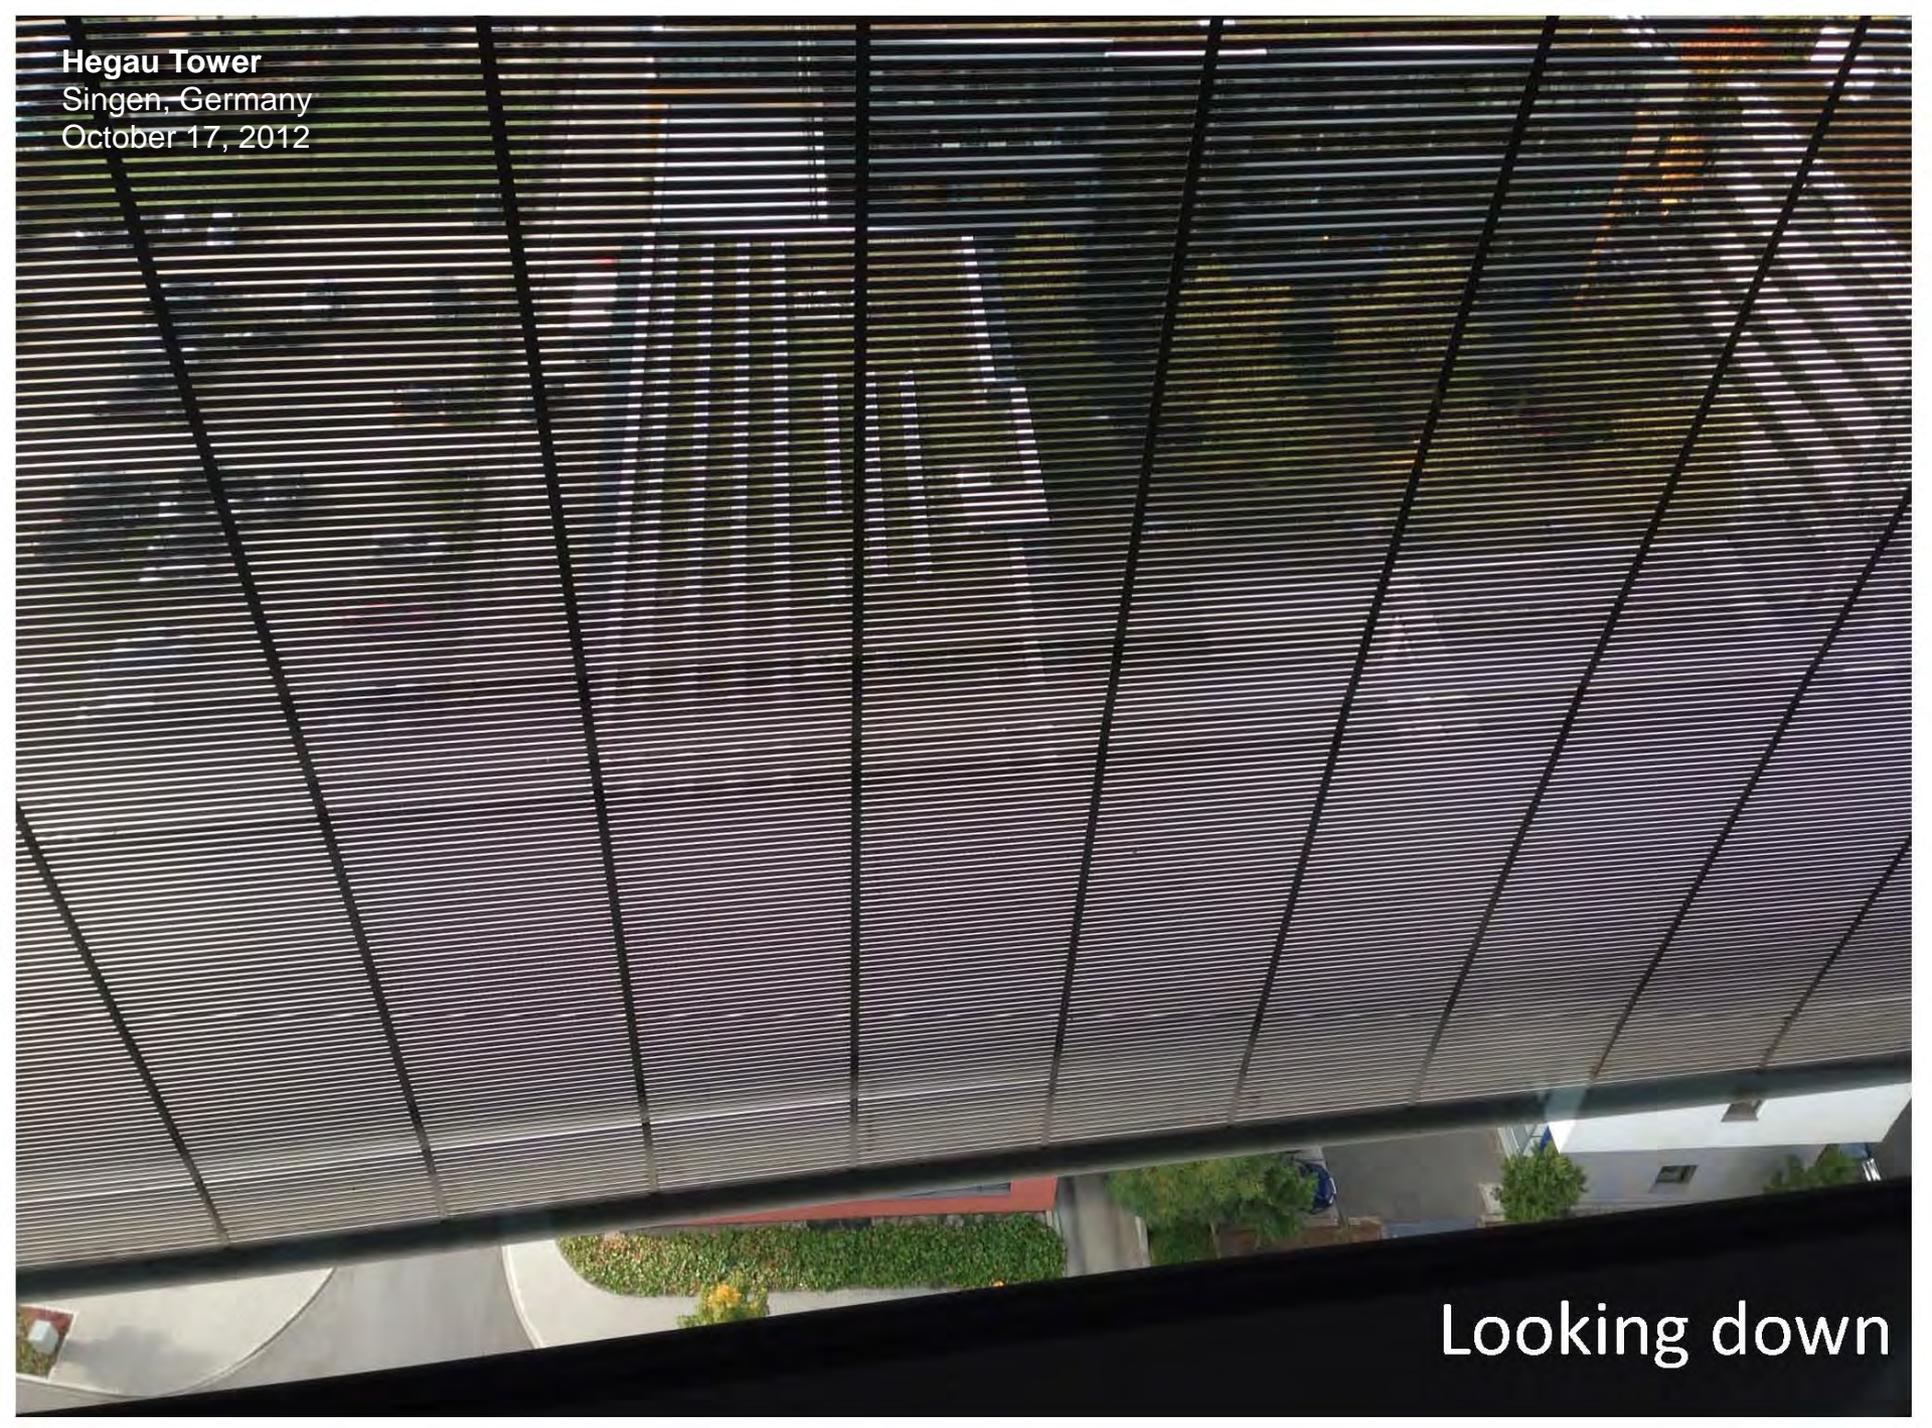
Looking up

Looking down

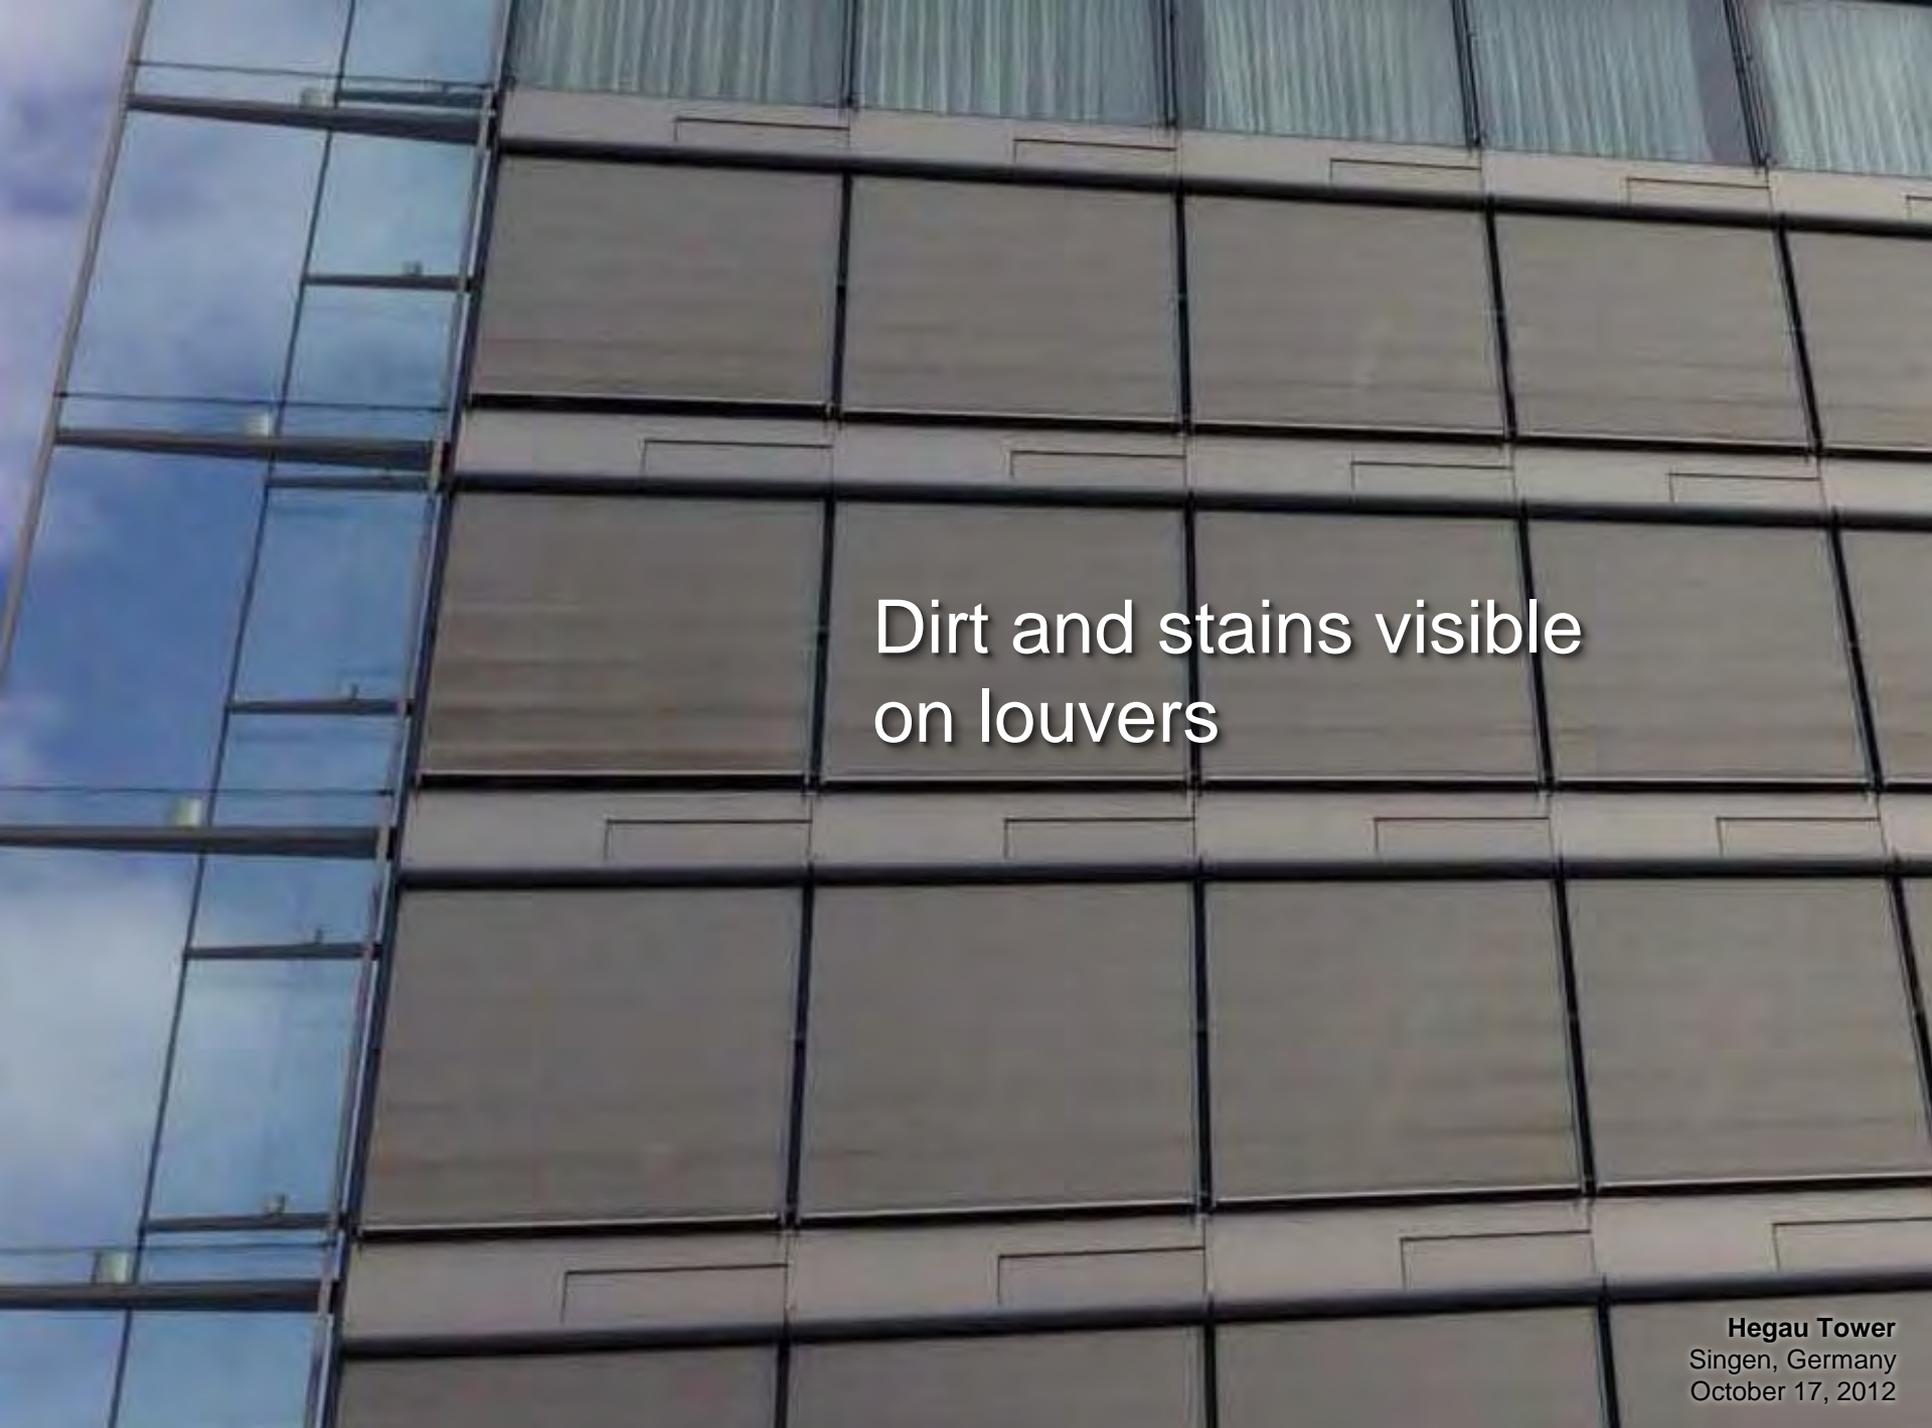
Dirt

Dirt and stains visible
on louvers

- Observations from the Hegau Tower show that the housing headers (rectangular boxes) protruding from curtain wall surface and the louvers themselves require frequent cleaning for dirt, debris, bird nests and droppings. The headers attract birds as a roosting site.
- Louver headers and tracks may interfere with current window washing equipment and may require modification.
- Louver interior surface can only be cleaned by removing the louvers.

CONCLUSION: Louver system will require a continuous, expensive, laborious effort to clean and repair to prevent it from becoming a visual eyesore for owners as well as those in the Arts District.

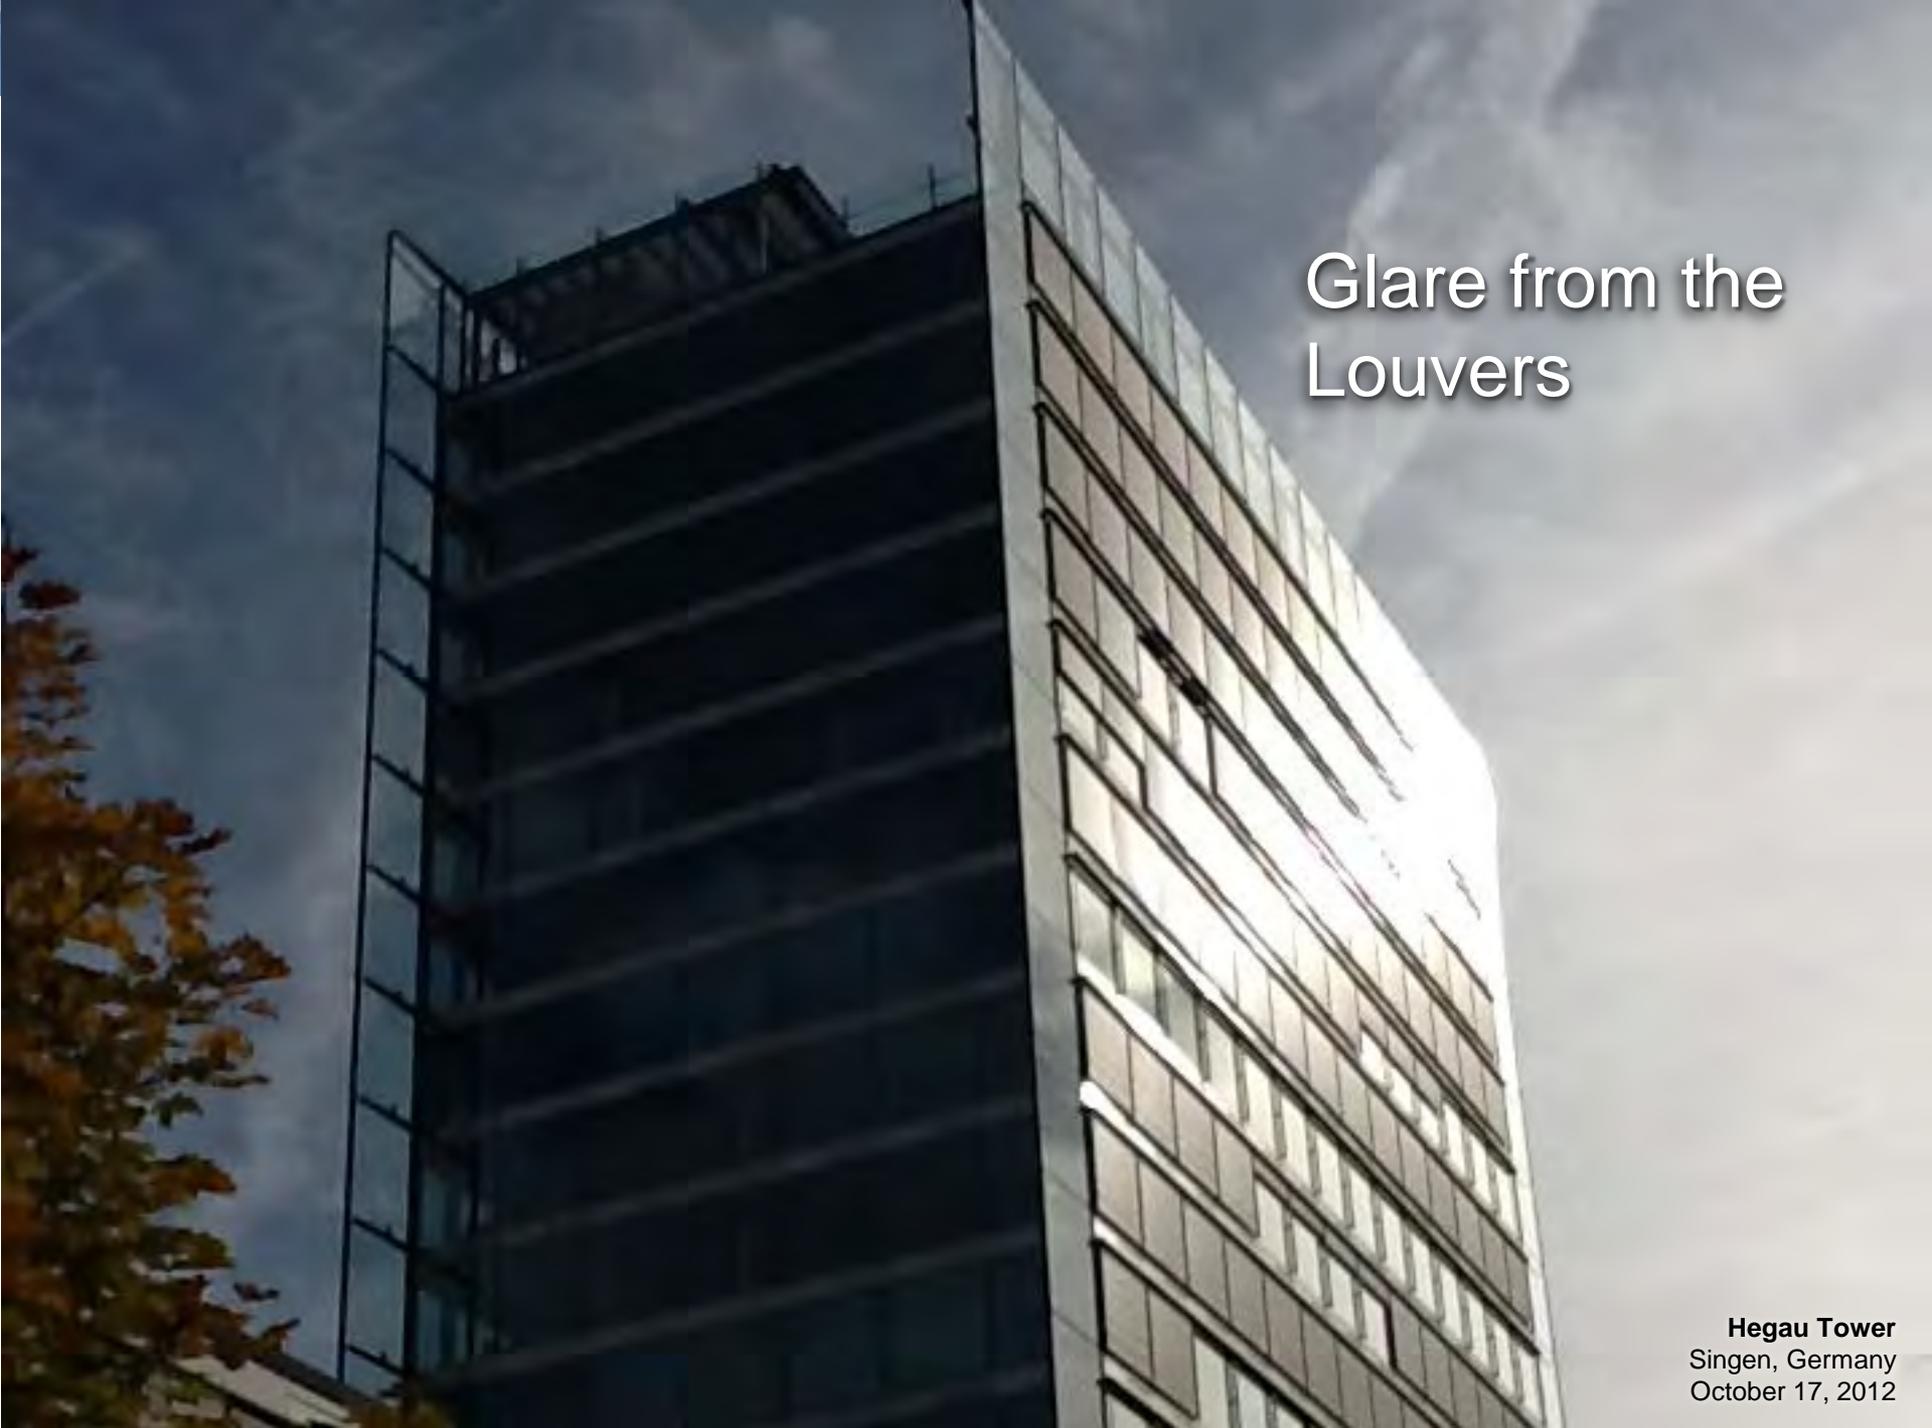
Glare from the Louvers

- According to Clauss Markisen, retractable louvers were designed to decrease the amount of solar heat entering the building and limit incoming ambient light.
- **This louver system reflects sunlight.**
- According to the manufacturer, this would be the first proposed application for a louver system to mitigate reflection. No test data, modeling or engineering reports exists for this new application.
- Current louver system is manufactured from reflective stainless steel. Louvers with low reflectance qualities are currently unavailable in the marketplace.
- Clauss Markisen has attempted to fabricate “darkened stainless steel” (to reduce reflectivity) louvers, but ran into fabrication problems.

CONCLUSION: This stainless steel louvered system reflects light. It is not designed to mitigate reflected sunlight. No computer control system exists to address the unique requirements for a louver system on Museum Tower.
